# Navajo Abandoned Uranium Mine

## Site Screen Report

**Mine Name: Montezuma No. 7C**  
**Mine ID: 535**

**Weston Solutions, Inc.**

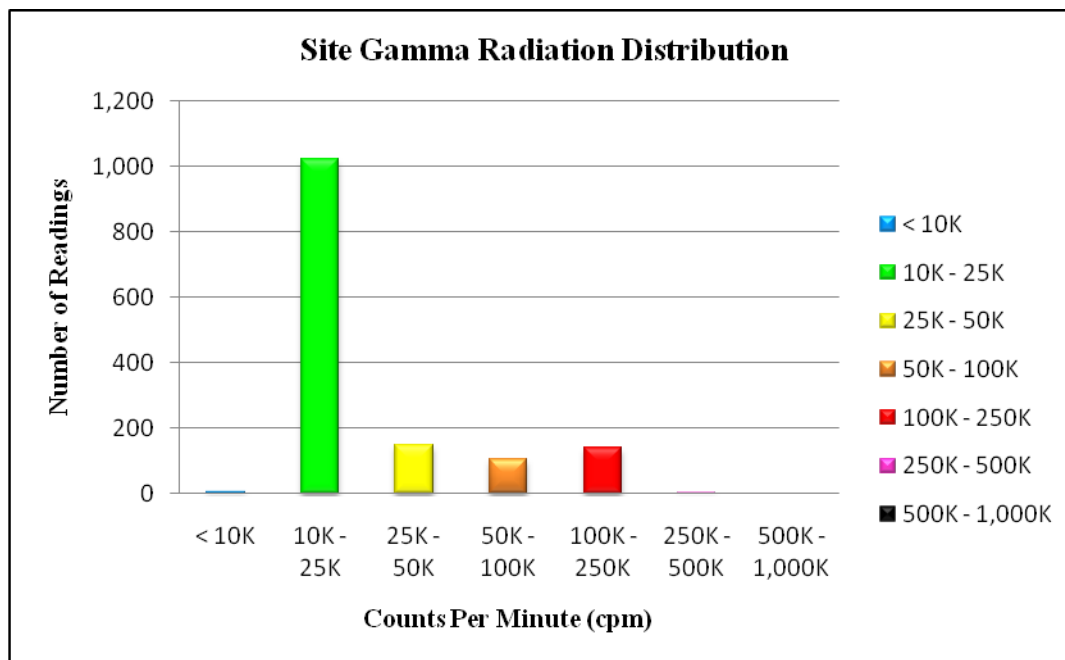
### Distribution Chart and Statistics:

<b>Site Gamma Radiation Statistics</b>	
Number of Readings	1,421
Minimum (cpm)	9,633
Maximum (cpm)	320,534
Mean (cpm)	36,743
Median (cpm)	16,440
Standard Deviation	48,991

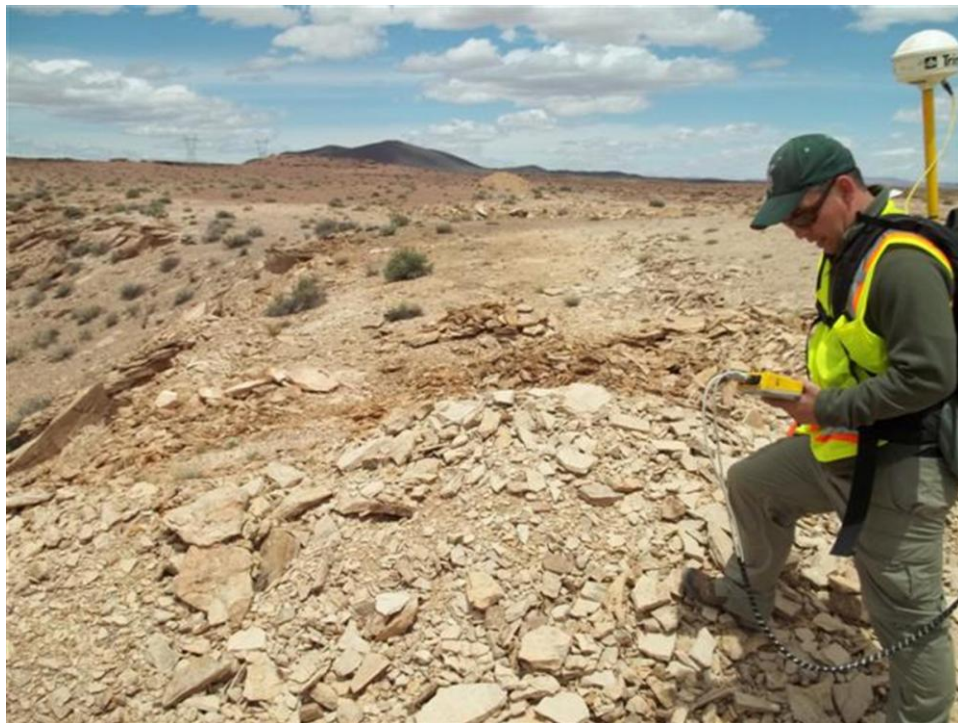
**Photo 3:** Mine Site #535; Small waste pile

Scattered waste rock atop site, approximately 50' x 100' x 3'; 2 waste rock piles: Pile 1 - 15'dia x 3'h; Pile 2 - 20'dia x 6'h

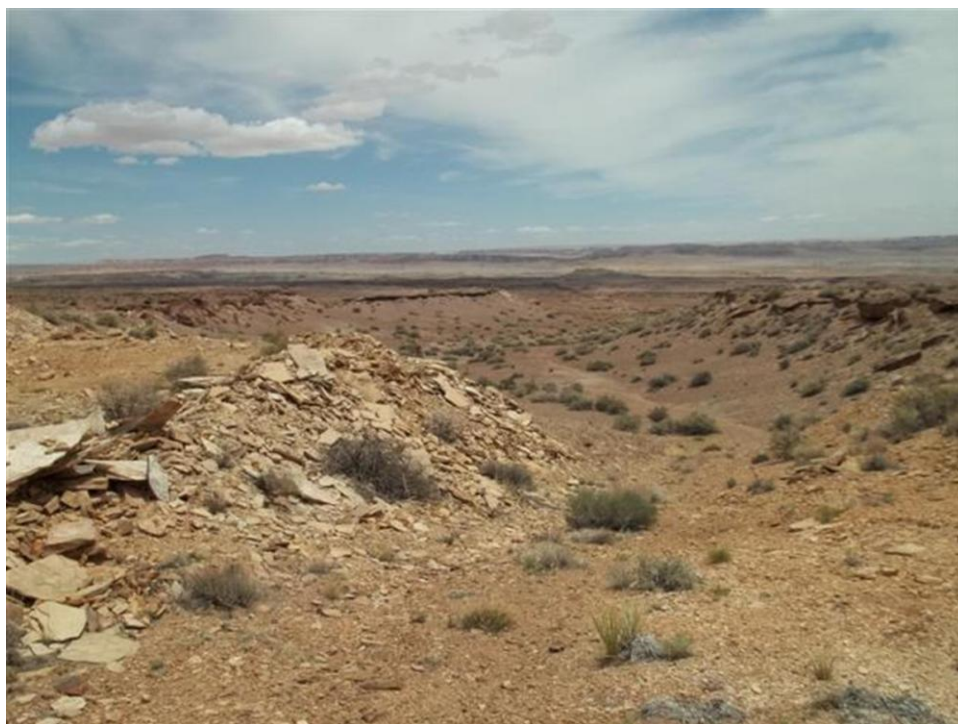
**Photo 4:** Mine Site #535; Medium waste pile

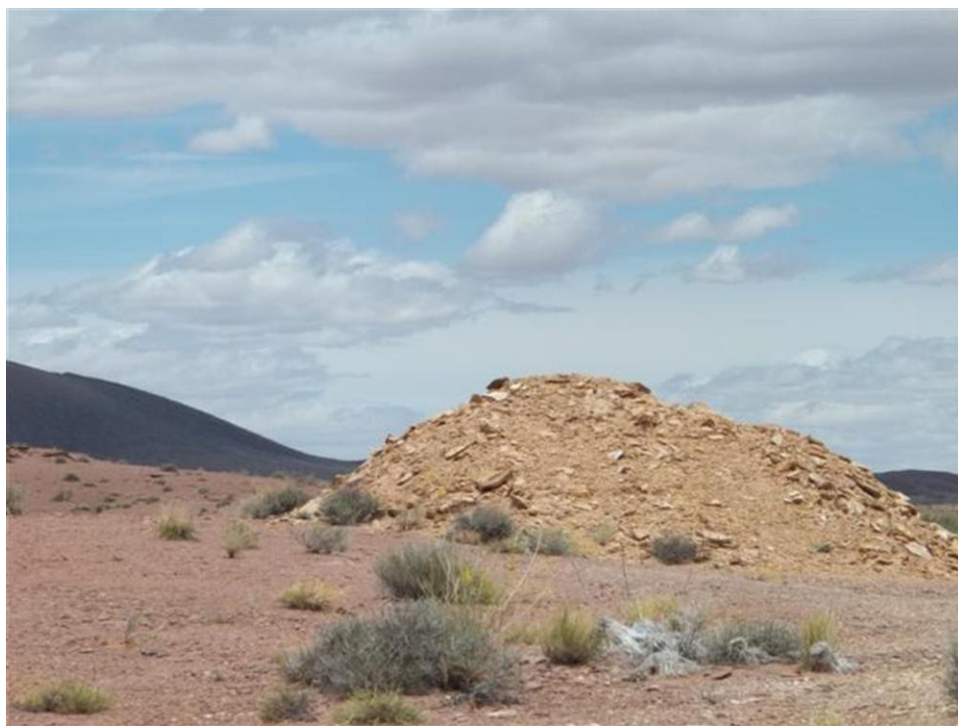
**Photo 5:** Mine Site #535; Large waste pile

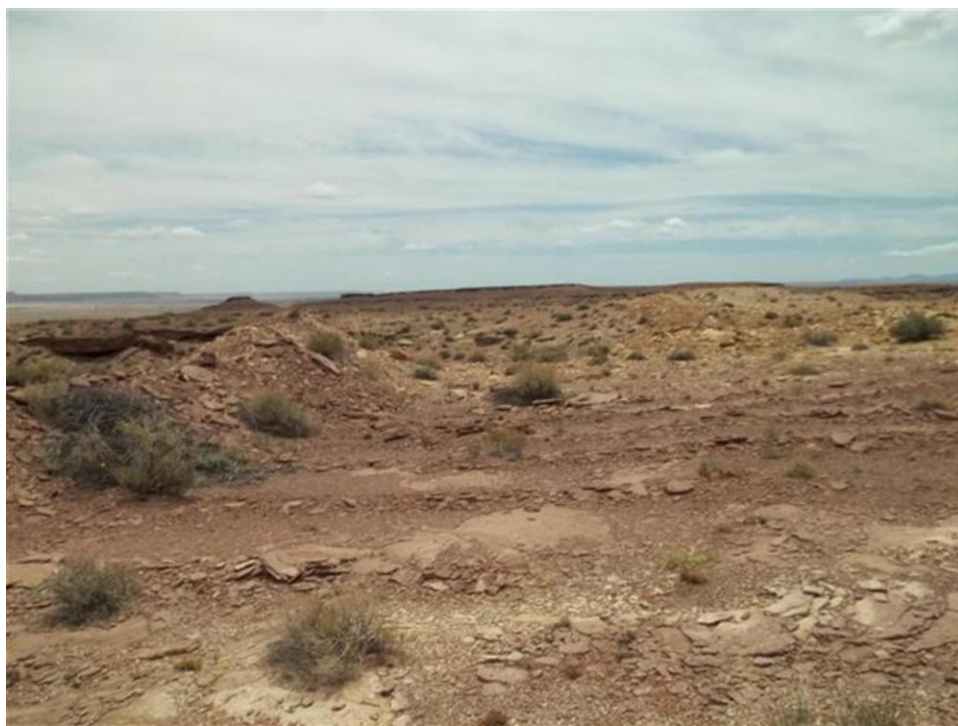
**Photo 6:** Mine Site #535; Reclamation area

Reclaimed area in north portion of site

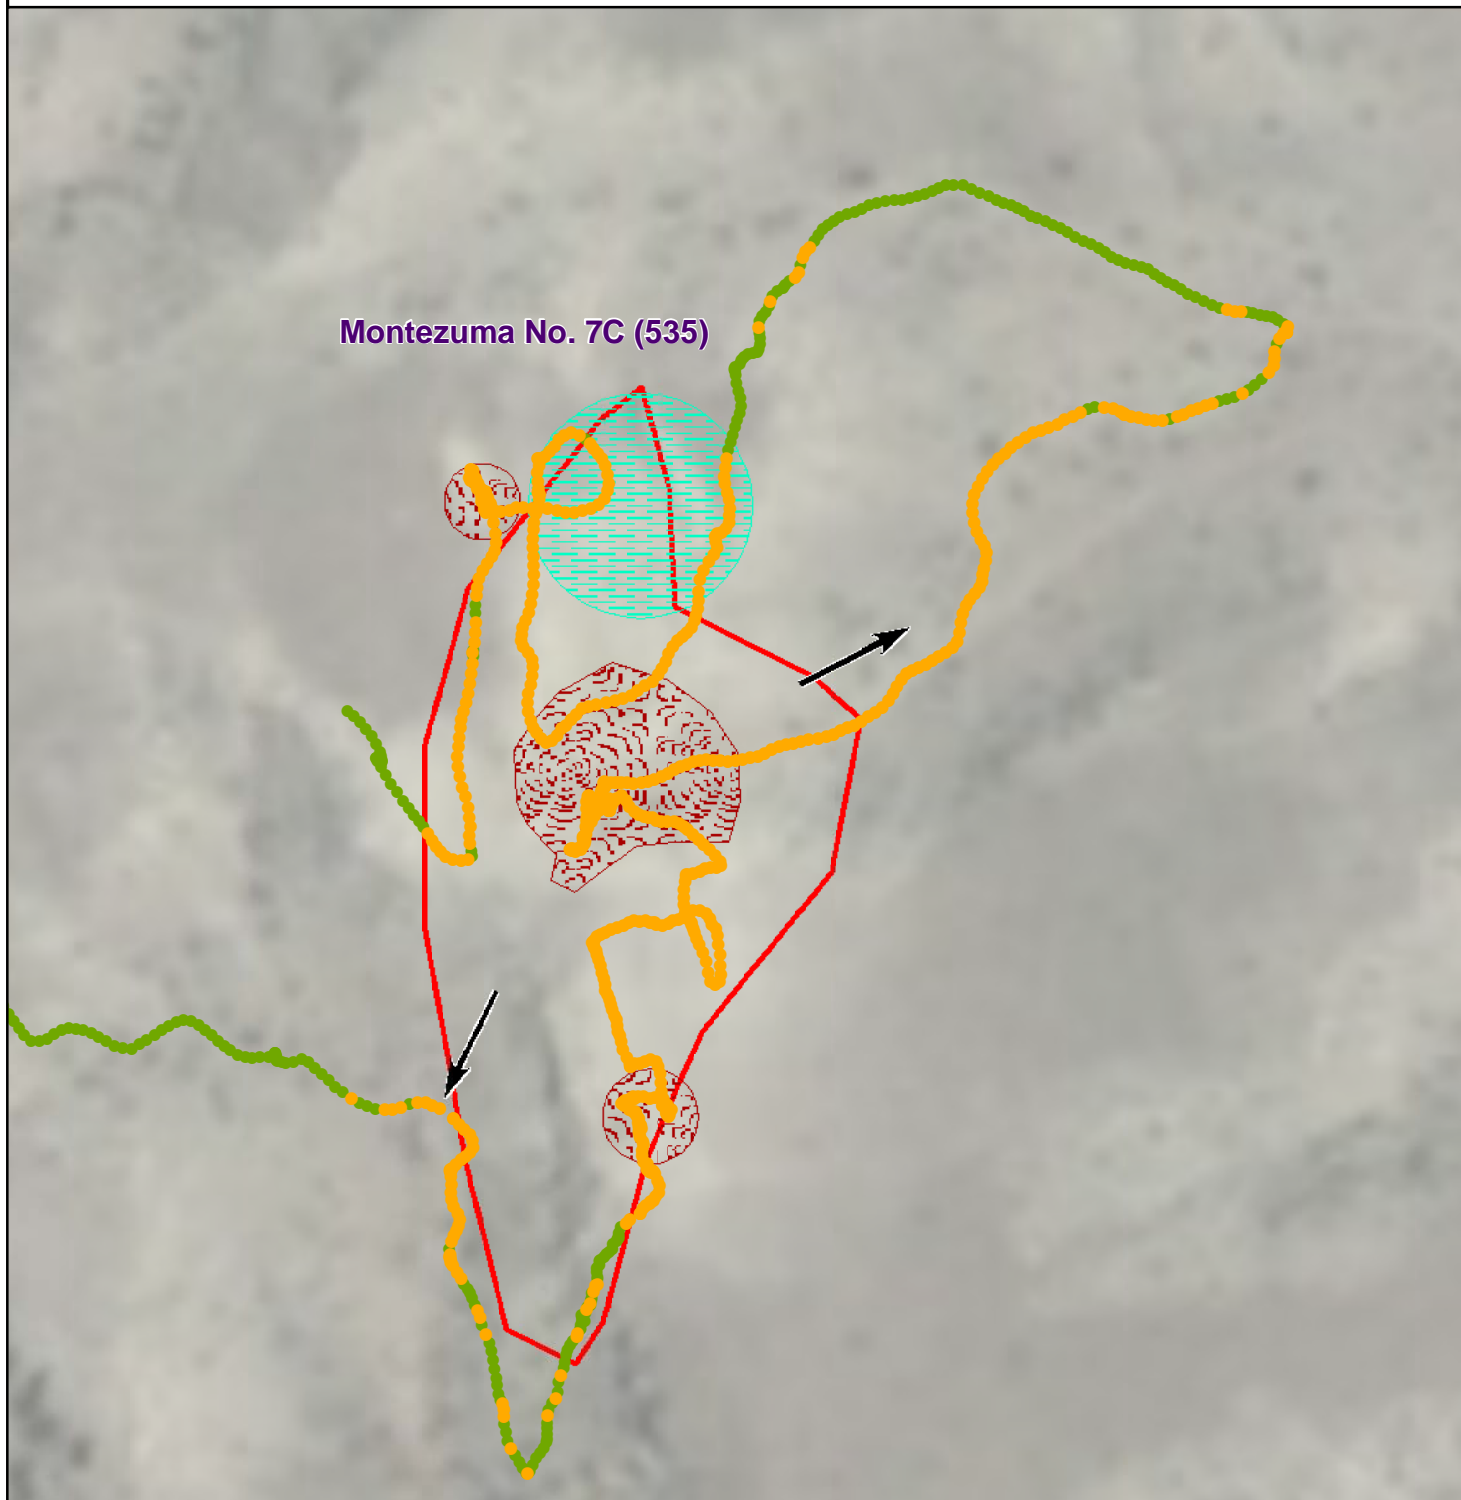
**Figure 1 - Gamma Radiation Measurements, Above Two Times Background  
Montezuma No. 7C (535)  
Bodaway / Gap Chapter, Navajo Nation**

Average background 8,412 cpm

A total of 1,421 gamma radiation measurements were collected from the mine site, ranging from 9,633 cpm to 320,534 cpm. Measurements collected in the vicinity of the waste rock were found at a maximum level of approximately 320,000 cpm, and the reclamation area of approximately 30,000 cpm. The measurements are represented in Figures 1 and 2.

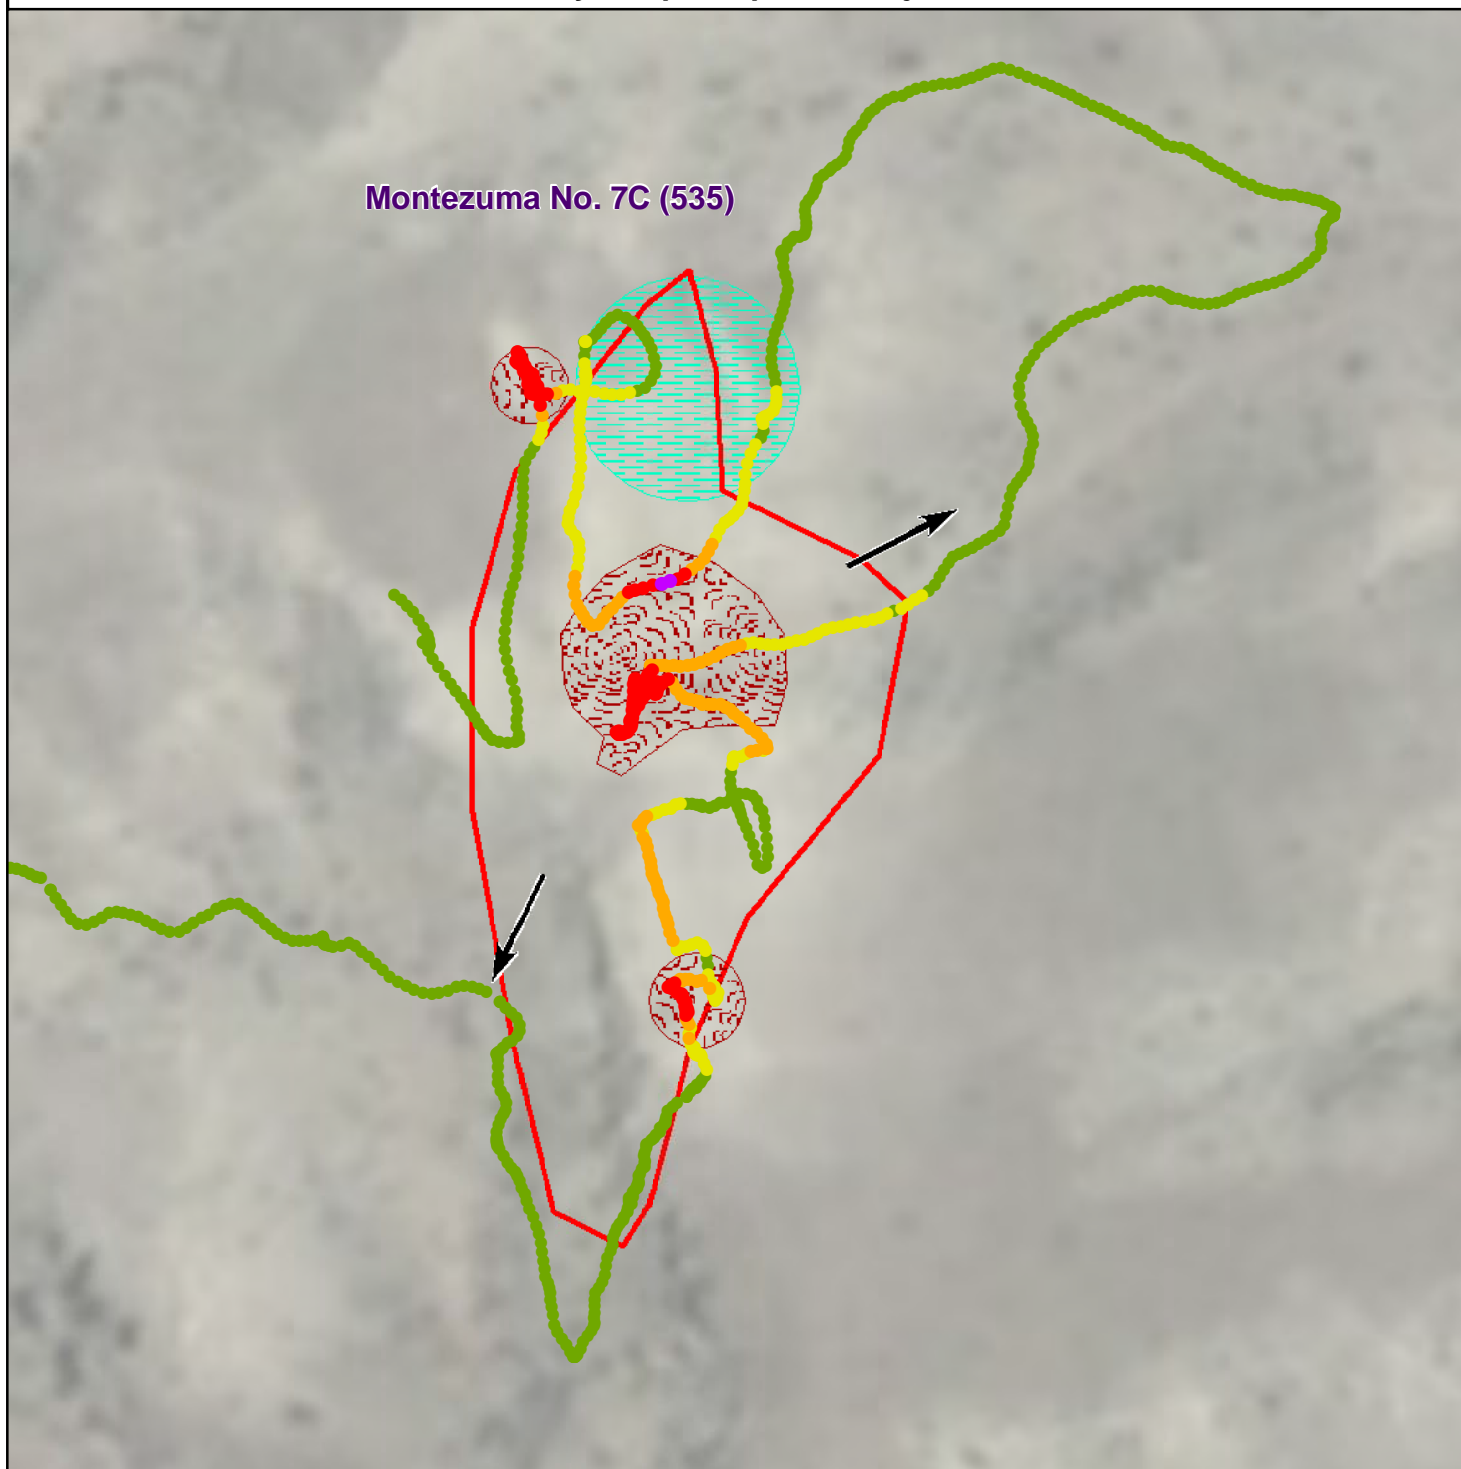
**Figure 2 - Gamma Radiation Measurements  
Montezuma No. 7C (535)  
Bodaway / Gap Chapter, Navajo Nation**

Measured as counts per minute (cpm)      Average background 8,412 cpm
